Detroit Arsenal Tank Plant First Five-Year Review Report

# **Detroit Arsenal Tank Plant**

Warren, Macomb County, MI

PREPARED BY:
US Army Corps of Engineers
Louisville District
CELRL-ED-E

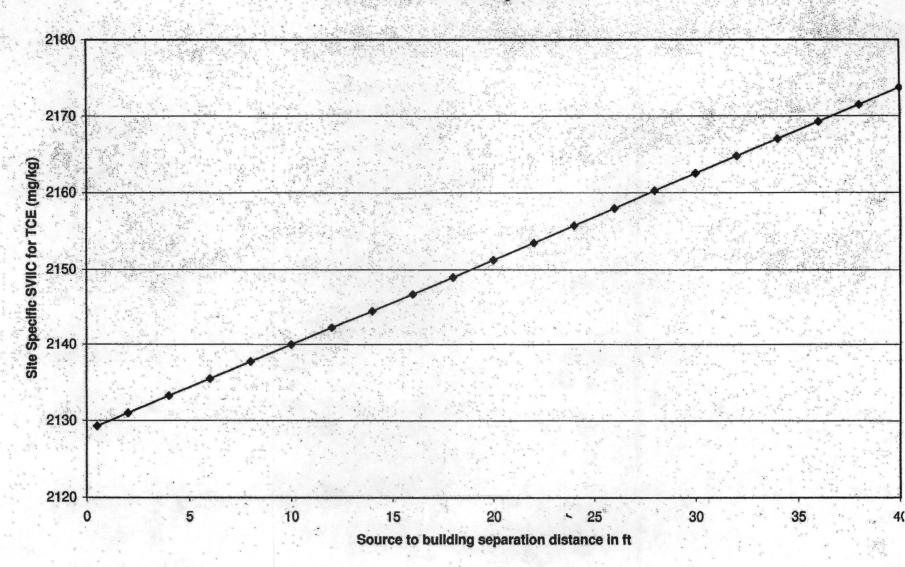
Figure 4 . Soil Volatilization to Indoor Air Inhalation Criteria (SVIIC) for TCE Infinite Source for Clay Loam Soil

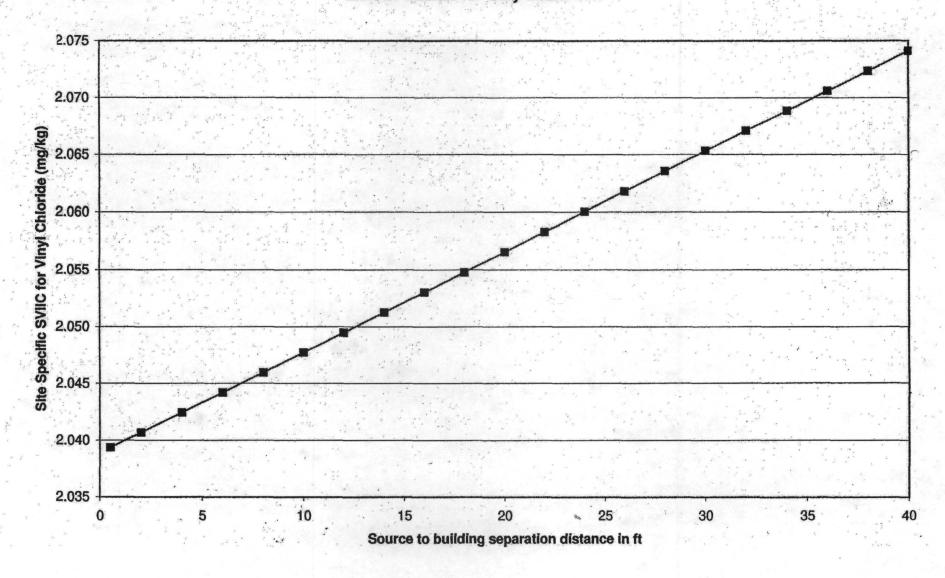
Figure 5 Soll Volatilization to Indoor Air Inhalation Criteria (SVIIC) for Vinyl Chloride Infinite Source for Clay Loam Soil

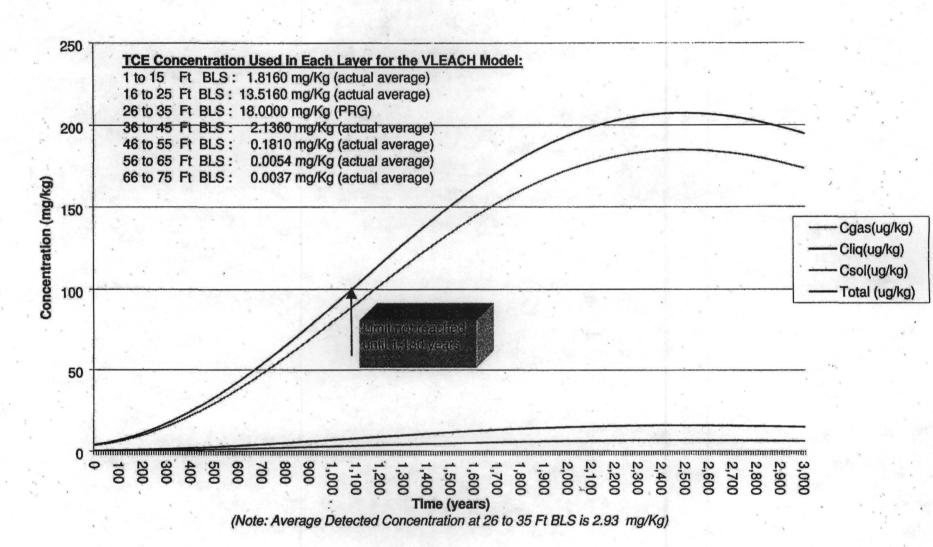
- Protection of inhalation of ambient air (for 5m thick source of contamination) 440 mg/kg for TCE and 9 mg/kg for vinyl chloride (MDEQ generic criteria).
- Protection of inhalation of indoor and ambient air depth-dependent value corresponding to a building area of 40,000 ft<sup>2</sup> calculated for site-specific conditions (see Figure 4 for TCE and Figure 5 for vinyl chloride).
- Migration to groundwater an average of 18 mg/kg TCE in the 26- to 34-foot BLS soil layer calculated for site specific conditions (see Figure 6).

Figure 6 Time to Reach Target TCE Concentration in Soil at 75 ft BLS
AREE 29 METAL DEBRIS DISPOSAL AREA
DETROIT ARSENAL TANK PLANT, WARREN, MICHIGAN

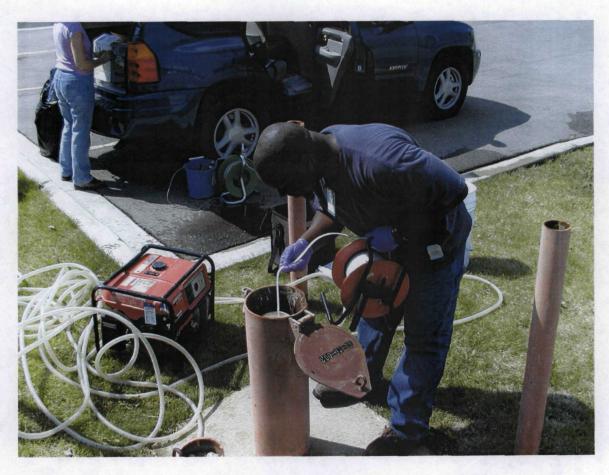
Photograph 1 AREE 29 - Long-term monitoring at the former Metal Debris Disposal Area, MW29-003.

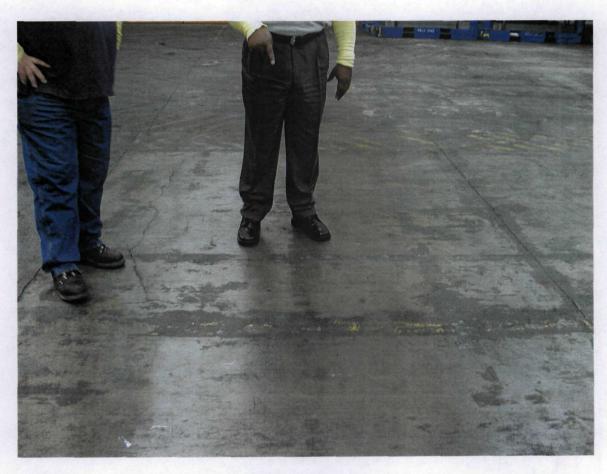
action, the floor was replaced (see Photograph 2 and Figure 3).

Photograph 2 AREE 2 - Inside what had been Building 4 where soil contaminated with chlorinated solvents had been removed from below the floor.

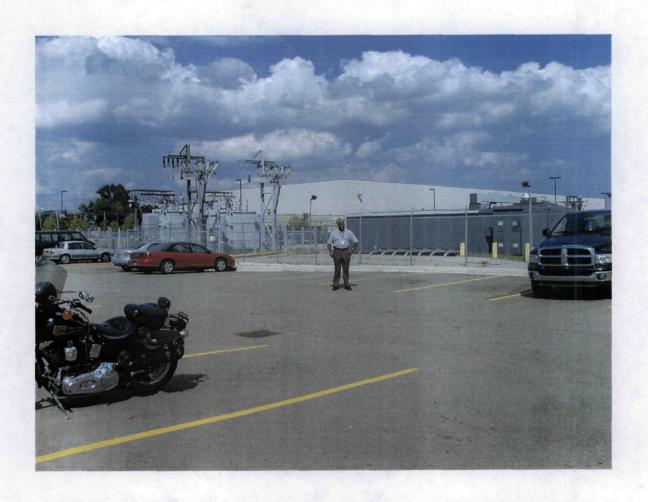
Photograph 3 AREE 13 - Printes Parker and Karen Rabek standing beside the Macomb County Community College along Van Dyke Road at the site of the former Building T-12. Photo taken looking south.

- AREE 13 Building T-12 has been demolished and the Michigan Technical Education Center of the Macomb County Community College now stands at the site. The actual area of the removal action is the grass lawn next to Van Dyke Avenue (See Photograph 3 and Figure 3).

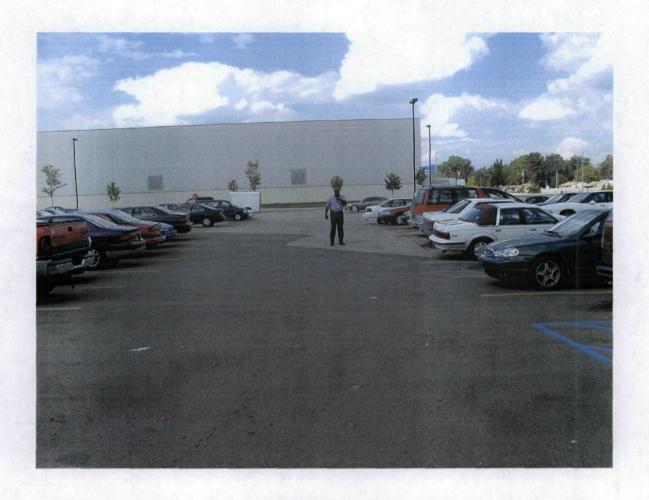
Photograph 4 AREE 14 - Printes Parker standing at location of the former Switchgear Housing site. Photo taken looking northeast.

- AREE 14 The Switch gear Housing site is paved over with parking lot (See Photograph 4 and Figure 3).
- AREE 15 The Building 26 Fuel Station Pump House is no longer standing. The site is now paved over (See Photograph 5 and Figure 3).

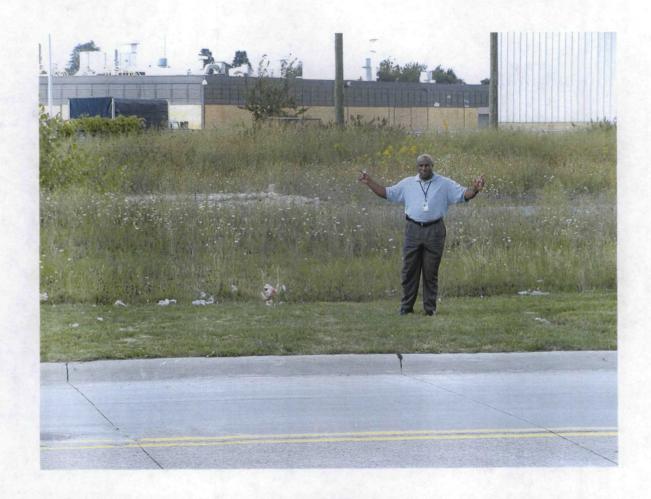
Photograph 5 AREE 15 - Printes Parker standing at the former location of the Building 26 Fuel Station Pump House. Photo taken looking south towards Building 4.

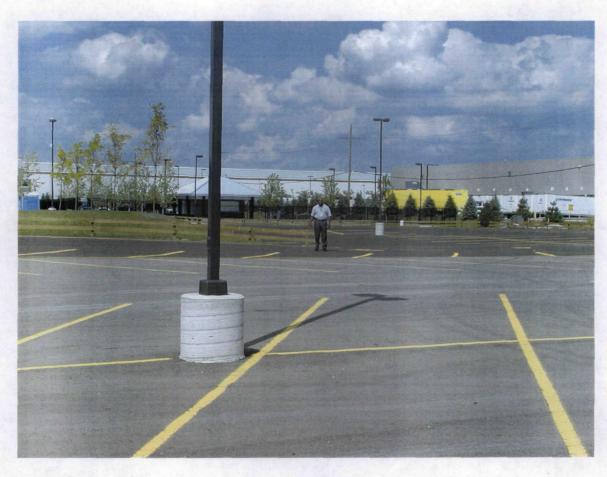
Photograph 6 AREE 22 - Printes Parker standing where the Central Heating Plant ASTs had been located. Photo taken looking northwest.

- AREE 22 The area where the ASTs had been removed at the Central heating Plant is now a grassy area beside the road (See Photograph 6 and Figure 3).
- AREE 29 The Metal Debris Disposal Area (MDDA) is now covered by paved parking lot for the UAW Region 1 Office Community and Retiree Center (See Photographs 7 and 8). The building has no basement as agreed to with the deed restrictions prohibiting digging. Quarterly and annual monitoring has indicated that groundwater has not been impacted by the TCE contamination from the MDDA. The area that had been the location of the Oily Waste Disposal Area (OWDA) is also covered by a paved parking lot (See Photograph 9). See Figure 3 for AREE 29 location.

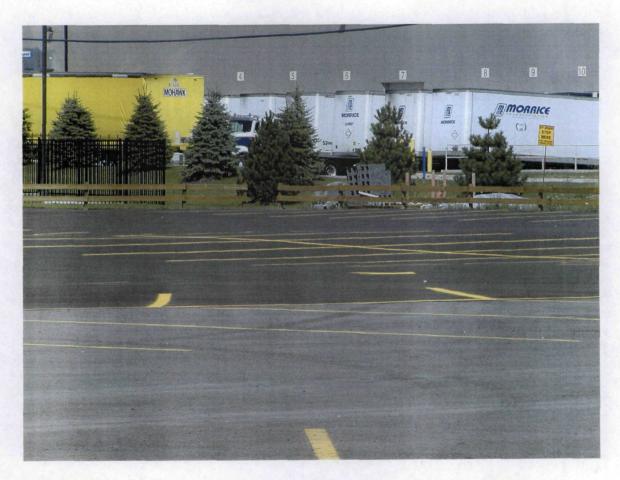
Photograph 7 AREE 29 - Printes Parker standing over what had been the Metal Debris Area site. Photo taken looking northeast.

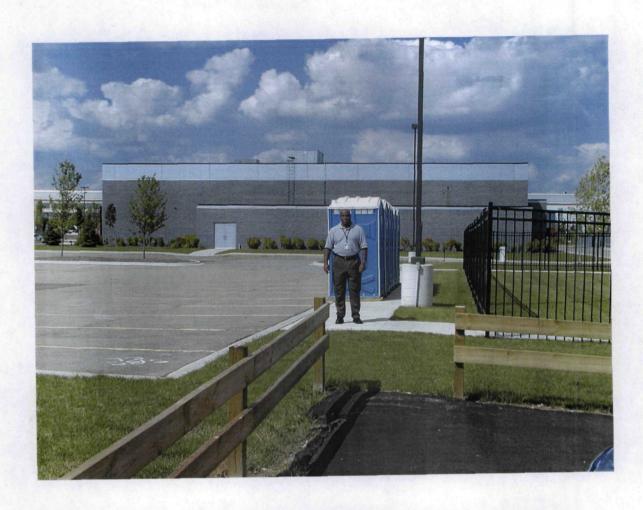
Photograph 8 AREE 29 - Former Metal Debris Area site. Photo taken looking northeast.

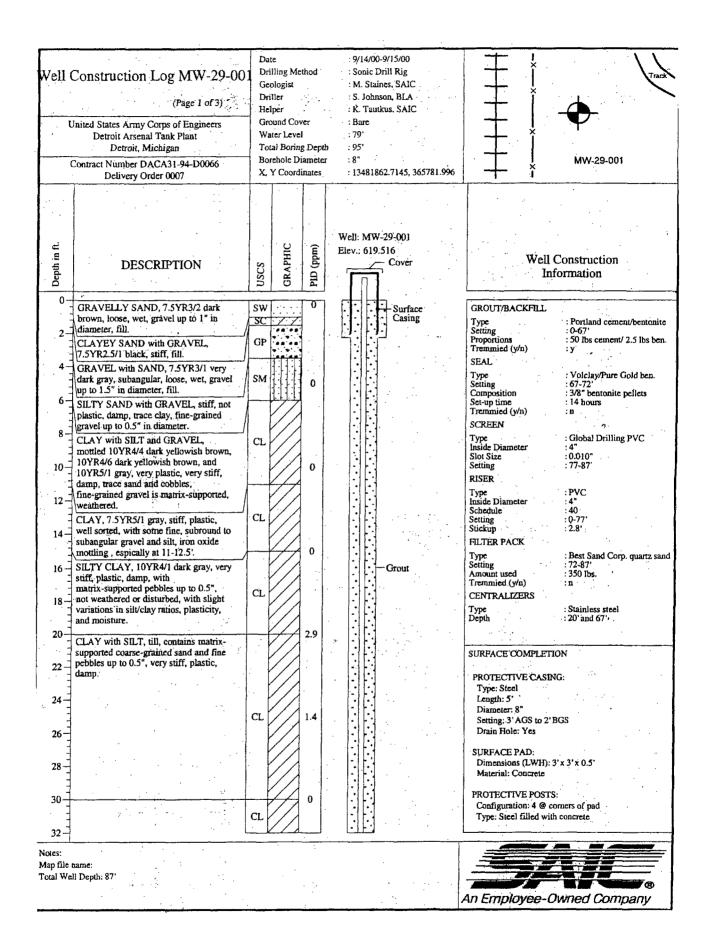
United States Army Corps of Engineers Detroit Arsenal Tank Plant Detroit, Michigan  Contract Number DACA31-94-D0066 Delivery Order 0007  DESCRIPTION  Solution Detroit, Michigan  Contract Number DACA31-94-D0066 Delivery Order 0007  Well: MW-29-001 Elev:: 619.516  Well: MW-29-001 Elev:: 619.516  Well: Construction Information  GROUT/BACKFILL Type Portland cement/ Setting Coarse sand, 30% silt.  CL  0.7  GROUT/BACKFILL Type Portland cement/ Setting Coarse sand, 30% silt.  CL  0.7  SEAL	Well Construction Log MW-29-00 (Page 2 of 3)	Date Drilling Method Geologist Driller Helper	: 9/14/00-9/15/00 : Sonic Drill Rig : M. Staines, SAIC : S. Johnson, BLA : K. Tautkus, SAIC	
Delivery Order 10007    Second Comment of the Process of Second Comment of Second Comment of Second Comment of Second Comment of Second Composition	Detroit Arsenal Tank Plant Detroit, Michigan	Ground Cover Water Level Total Boring De	: Bare : 79' pth : 95'

DESCRIPTION  By B		1		
SILTY (A) (NYRAI) very dark gray, very plastic, with firm, slightly moist, very plastic, soft, very plastic, soft, very plastic, soft, very plastic, very sliff, damp, 25% of interval is very plastic, very plastic, very viliff, damp, 25% of interval is clay with ruce silt and large chunks of 100% clay, very plastic, firm, moist, with 1% stands firm, moist, with 1% clay silf, firm, slightly moist, 15.20% silf and 1% noist, firm, moist, with 1% clay clay silf, firm, moist, with 1% clay clay clay silf, firm, slightly moist, 15.20% silf and firm, slightly moist, 15.20% silf and firm slightly moist,	CL UL UL UL UL UL UL UL UL UL UL UL UL UL	USCS GRAPHIC PID (pom)		· .
CLAY with SILT, 19YR4/I very dark gray, very plastic, very plastic, soft, no pebbles, with trace silt and large chunks of 100% clay, very plastic, two promoted by the clay with trace silt and large chunks of 100% clay, very plastic, fram moist.  CLAY, 10YR4/I very dark gray, very plastic, fram clay silt, moist, 10YR4/I very dark gray, very plastic, fram moist, soft, very plastic, fram moist, soft, very plastic, fram moist, with 1% matrix-supported pebbles and coarse said. 2.5° cobble at 55° and other well rounded pebbles up to 2.5°.  CLAY, 10YR4/I very dark gray, very plastic, fram moist soft with trace silt, moist, soft, very plastic.  CLAY with SILT, 10YR4/I very dark gray, very plastic, fram moist and plastic, very stiff, damp, 25% of interval is clay with trace silt, moist, soft, very plastic.  CLAY, 10YR4/I very dark gray, very plastic, fram moist soft with plastic, very stiff, damp, 25% of interval is clay with trace silt, moist, soft, very plastic.  CLAY, 10YR4/I very dark gray, very plastic, fram moist with 1% matrix-supported pebbles and coarse said. 2.5° cobble at 55° and other well rounded pebbles up to 25°.  CLAY with SILT, 10YR4/I very dark gray, with seams of gon-plastic silt, 30% silt.  CL Dimensions (LWH): 3° x 3° x 0.5° Material: Concrete configuration: 4 @ corners of pad Type: Steel filled with concrete	SILTY CLAY, 10YR4/1 very dark gray, firm, slightly moist, very plastic, with trace matrix-supported fine pebbles and coarse sand, 30% silt.	CL 0.7		Type : Portland cemer Setting : 0-67' Proportions : 50 lbs cement/ Tremmied (y/n) : y  SEAL  Type : Volclay/Pure G Settine : 67-72'

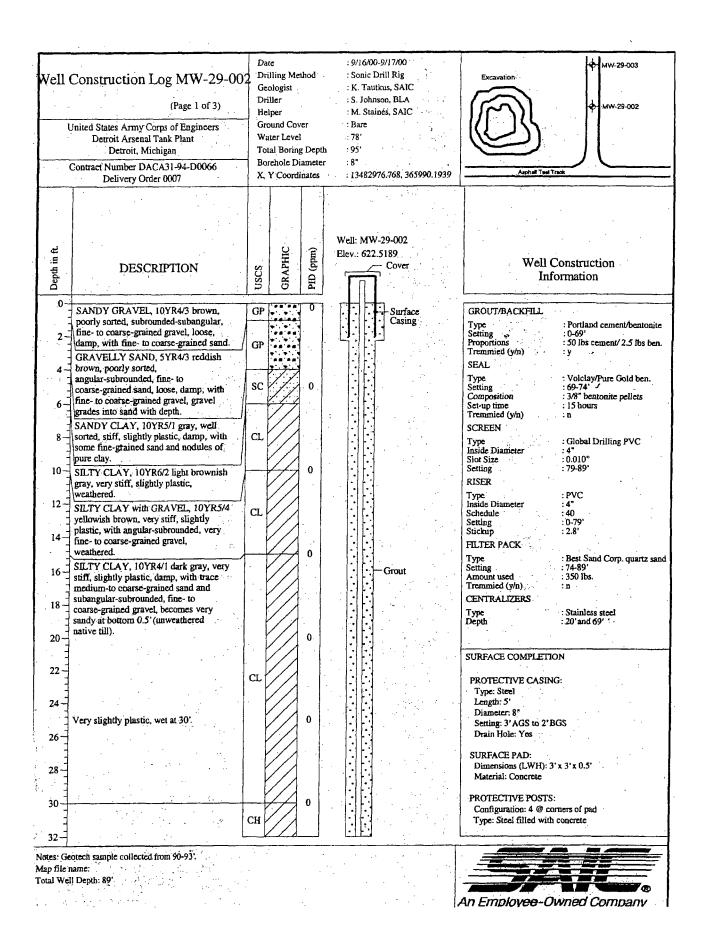
· t	Construction Log MW-29-002  (Page 2 of 3)  United States Army Corps of Engineers Detroit Arsenal Tank Plant Detroit, Michigan  Contract Number DACA31-94-D0066 Delivery Order 0007	Geolog Driller Helper Ground Water Total I Boreho	d Cover	pth ter	: 9/16/00-9/17/00 : Sonic Drill Rig : K. Tautkus, SAIC : S. Johnson, BLA : M. Staines, SAIC : Bare : 78' : 95' : 8" : 13482976.768, 365990.1939	Excavation MW-29-003  Alghal Text Track
Depth in ft.	DESCRIPTION	USCS	GRAPHIC PID (ppm)	1	Well: MW-29-002 Elev.: 622.5189	Well Construction Information
50- 52- 54- 56- 58-	CLAY, 10YR4/1 dark gray, very stiff, very plastic, damp, with medium-to coarse-grained sand and fine- to coarse-grained gravel decreasing with depth until only trace medium-to coarse-grained sand at 40'. Wet at 31'.  CLAY, 10YR4/1 dark gray, slightly soft, very plastic, moist, with trace medium-to coarse-grained sand and fine-to medium-grained gravel.  SANDY CLAY, 10YR4/1 dark gray, very soft, slightly plastic, wet, with fine- to coarse-grained sand.  CLAY, 10YR4/1 dark gray, slightly stiff, very plastic; moist, with some fine- to coarse-grained sand and subangular-rounded fine-grained gravel.  Decreasing amounts of gravel.	CH	0 0		Grout	GROUT/BACKFILL Type : Portland cement/bentonin Setting : 0-69" Proportions : 50 lbs cement/ 2.5 lbs be Tremmied (y/n) : y SEAL Type : Volclay/Pure Gold ben. Setting : 69-74' Composition : 338" beptonite pellets Set-up time : 15 hours Tremmied (y/n) : n SCREEN Type : Global Drilling PVC Inside Diameter : 4" Slot Size : 0.010" Setting : 79-89' RISER Type : PVC Inside Diameter : 4" Schedule : 40 Setting : 0-79' Stickup : 2.8' FILTER PACK Type : Best Sand Corp. quartz se Setting : 74-89' Amount used : 350 lbs. Tremmied (y/n) : n CENTRALIZERS Type : Stainless steel Depth : 20' and 69'  SURFACE COMPLETION  PROTECTIVE CASING: Type: Steel Length: 5' Diameter: 8" Setting: 3' AGS to 2' BGS Drain Hole: Yes  SURFACE PAD: Dimensions (LWH): 3' x 3' x 0.5' Material: Concrete  PROTECTIVE POSTS: Configuration: 4 @ corners of pad Type: Steel filled with concrete

Notes: Ge Map file 1 Total Wel	otech sample collected from 90-93'.  name: 1) Depth: 89'					An Employee-Owned Company
